NPIC/R-1583/63 December 1963

# MUNITIONS STORAGE SITE NEAR KUN-MING, CHINA

COORDS: 25-03N 102-50E NPIC TARGET NO: 0496-11-Q

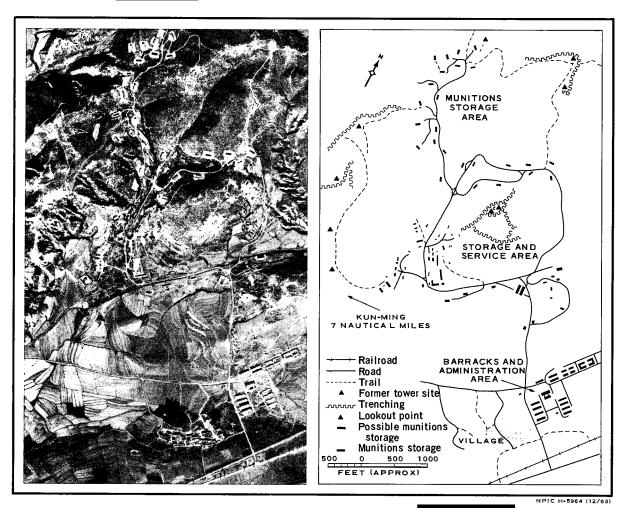
FIGURE 2. MUNITIONS STORAGE SITE NEAR KUN-MING, CHINA

A munitions storage site, reported previously as "Kun-ming Explosives Storage,"  $\underline{1}$ /is located 7 nm east of Kun-ming, Yun-nan Sheng (Province), China (Figure 1). The site consists of three areas: a munitions storage area in the hills, a storage and service area, and a barracks

and administration area (Figure 2). The latter areas are located in a valley SE of the munitions storage area. The site is close to a main rail line, but is road served only. Construction of the rail line began prior to and was completed before. A series of military installations, including probable explosives storage areas, are located along the railroad.

Munitions Storage Area. The munitions storage area contains 25 dispersed storage buildings and one small building of unidentified

no roof ventilators are visible. Three sizes of warehouses are discernible: 70 by 25 ft, 65 by 30 ft, and 50 by 25 ft. The total roof cover of the 25 warehouses is about 42,000 sq ft. This area was complete when it was first observed on photography of

function. The storage buildings are gable roofed;

Security. Extensive trenching is visible along the perimeter of the munitions storage area and at lookout points, suggesting the use of troops for external security purposes. Three guard towers, observed on photography, had been removed by

Storage and Service Area. The storage and service area contains about 50 storage and support buildings, including at least 12 dispersed storage buildings possibly used for munitions. All the buildings in this area were present in 25X1D

Barracks and Administration Area. A barracks and administration area, located near the entrance to the site, contains 19 buildings including at least 15 barracks. Construction in this area was just beginning in four barracks were incomplete as of
